INDIGENOUS APPROACH TO SOIL EROSION CONTROL IN THE SOUTHWEST NIGERIA

Matthew IBITOYE and Suleiman ADEGBOYEGA, Nigeria

SUMMARY

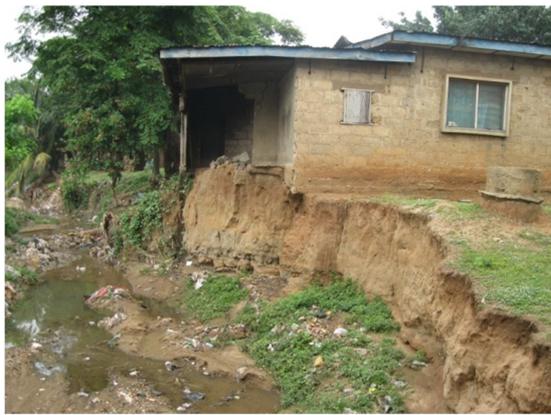
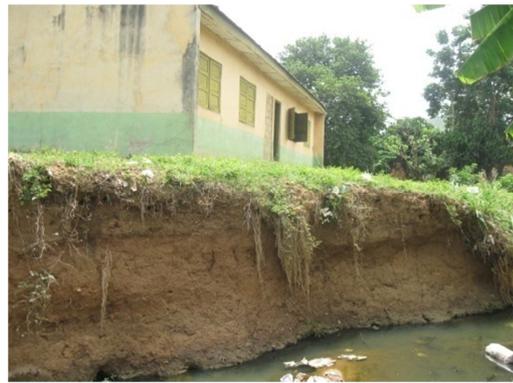
Plates a-b: Effects of gully erosion on the housing properties

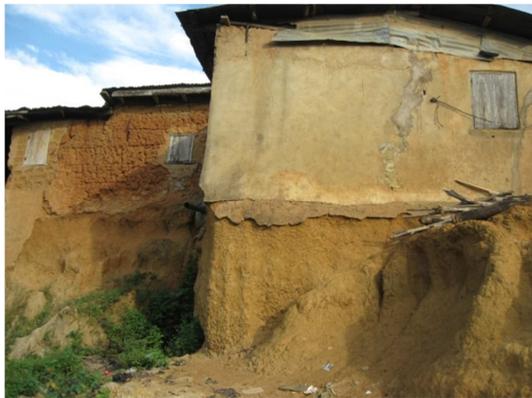
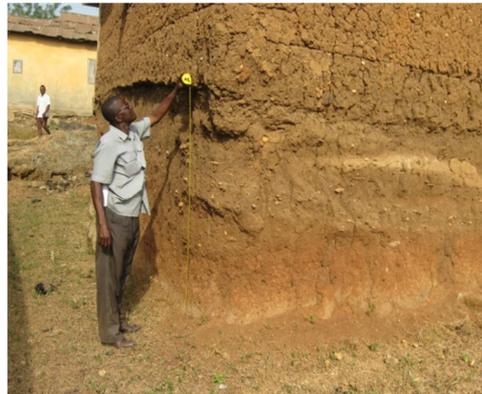
Plates c-d: Effects of sheet erosion on housing properties

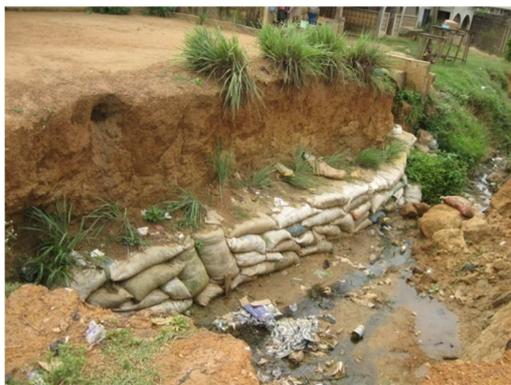
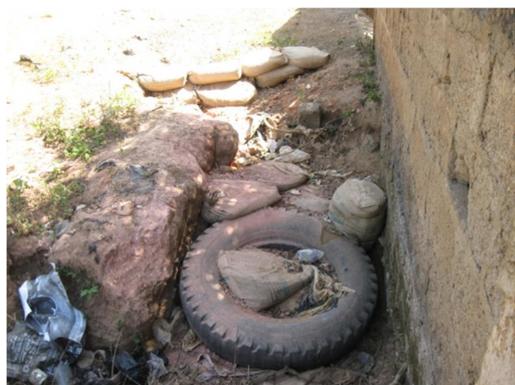
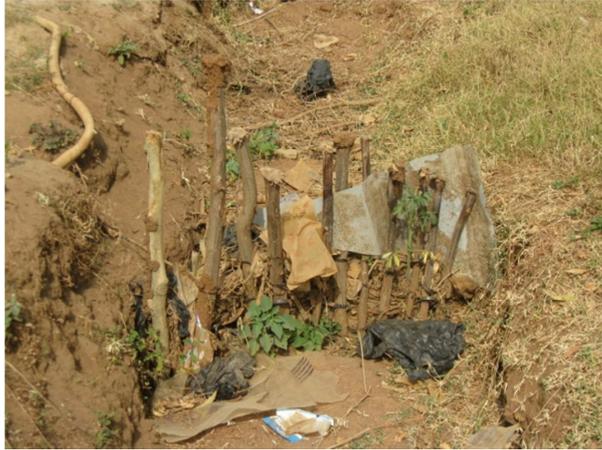
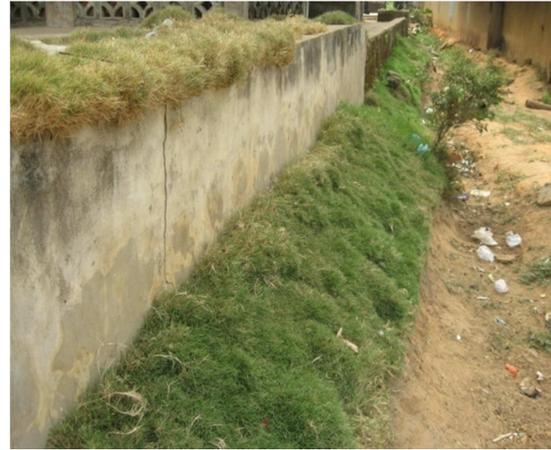
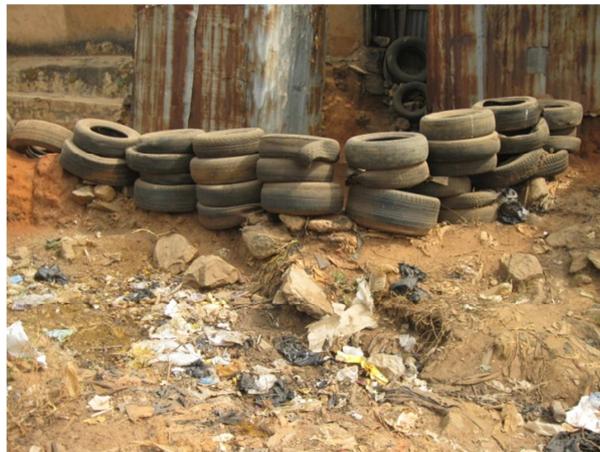
Plates e-i : Examples of indigenous methods of erosion controls
