Three-Dimensional Laser Scanning Test in Aircraft Surfaces

Luis MIRANDA and Daniel PAEZ, Universidad de los Andes, Colombia

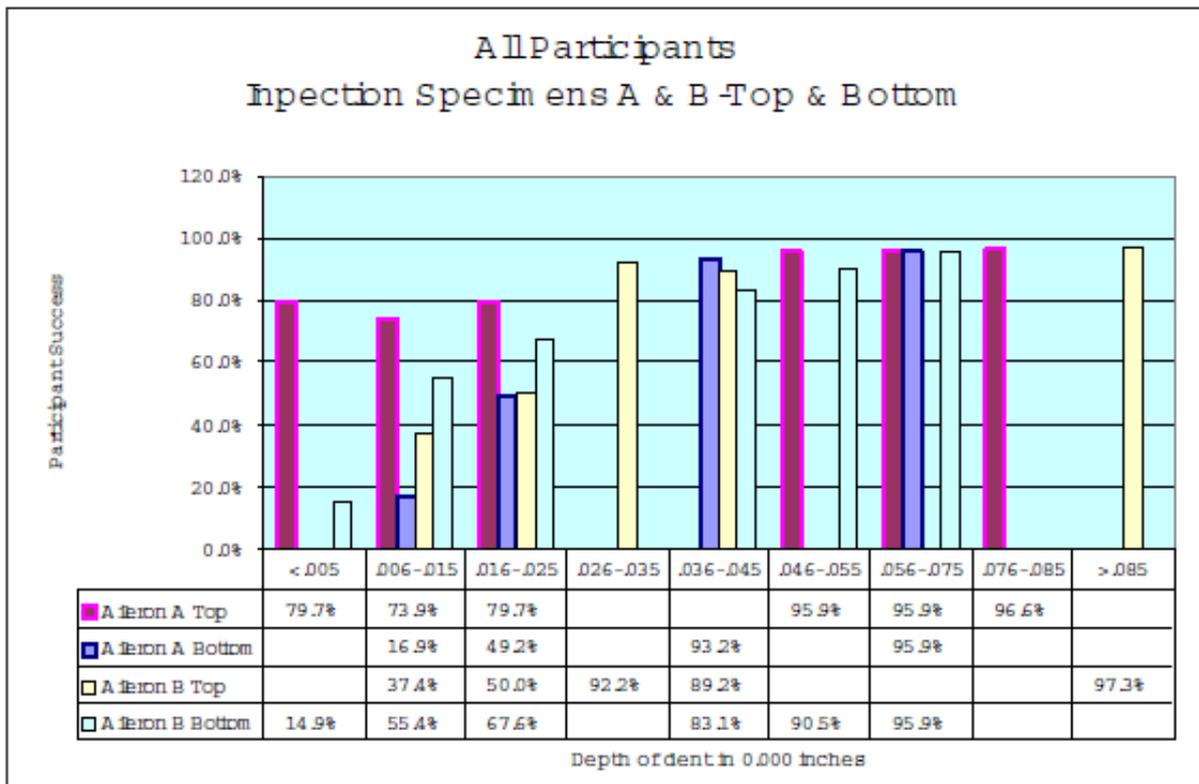
FIGURE 1. SUMMARY GRAPH, PARTICIPANTS-INSPECTION SPECIMENS A&B (ERCHART, OSTROM, & WILHELMSEN, 2004)

Figure 1 shows that there is no clear differentiation in the attention to details between men or women. It also shows that dents greater than 0.06 inches are identifiable in more than 80% of cases. It is, therefore, questionable that current visual inspections are sufficient as there are a 20% of dents that are not identified, compromising flight safety (Erchart, Ostrom, & Wilhelmsen, 2004).

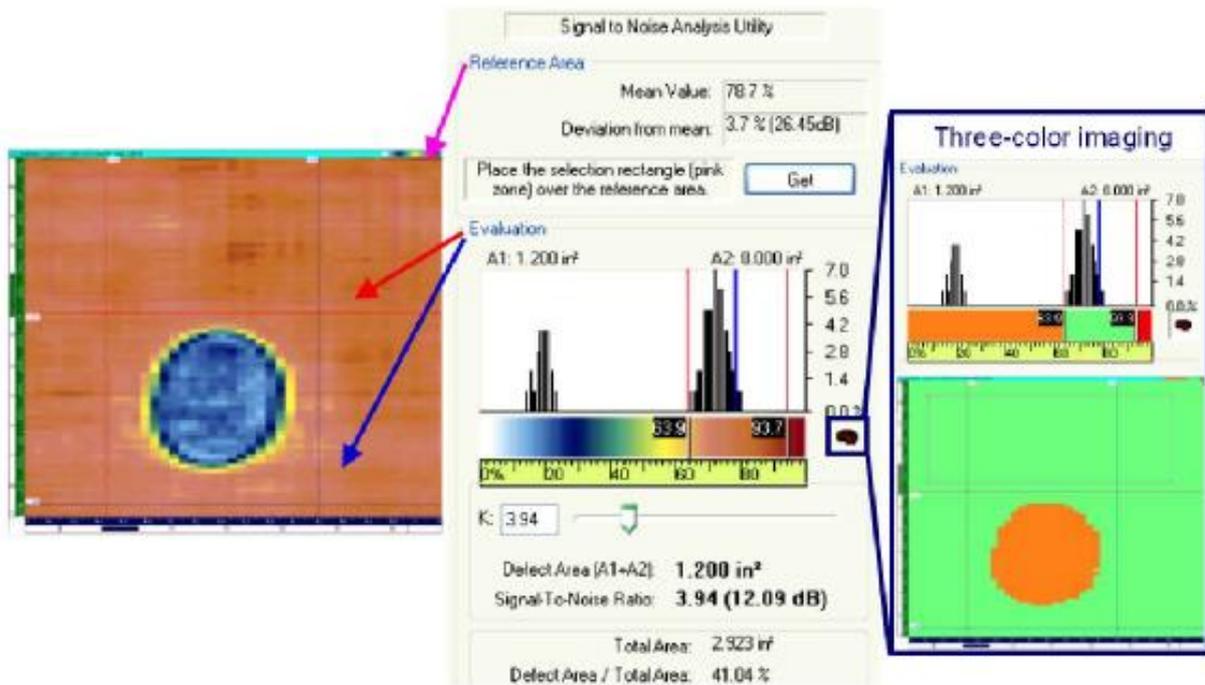
FIGURE 2. REPRESENTATIVE RESULTS ON AN AMPLITUDE C-SCAN (LEFT), C-SCAN CONVERTED INTO THREE COLORS FOR ASSISTED DEFECT VIEWING (RIGHT) (HABERMEHL, LAMARRE, & ROACH, 2009)

With this, technique data interpretation is easier compared to amplitude or time-of-flight (TOF) because a color-coded map of large areas is provided by the C-scans, where echo amplitudes are recorded in relation to probe position and represent the main defect viewing. To detect all defects from areas the previously mentioned scans require an appropriate gate. However, in some cases it can be used the amplitude base method, that doesn't requires an appropriate gate by a direct delamination detection or monitoring the backwall drop. Regardless of the good results of the methods mentioned before, there are some limitations with the mid-range (Habermehl, Lamarre, & Roach, 2009).

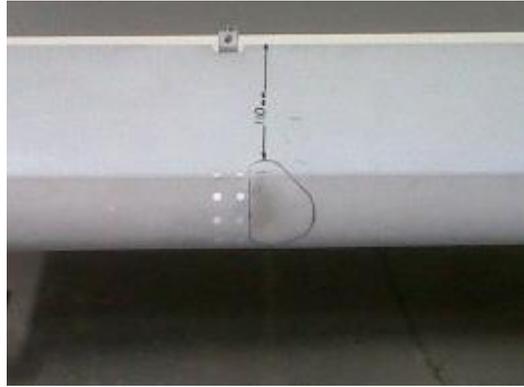
The case of study was divided in three parts. The first part is a laboratory situation where the engineers need to measure a previous identified dent on an A320 leading edge shown in Figure 4.

FIGURE 4. DENT ON A320 LEADING EDGE

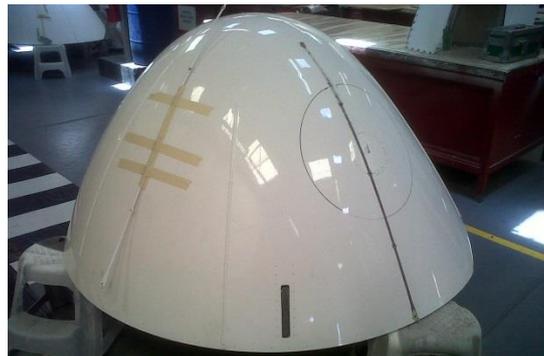
The second part is a laboratory situation where the engineers need to identify a scratch on an A320 quartz fiber nose radome, shown in Figure 5.

FIGURE 5. A320 NOSE RADOME

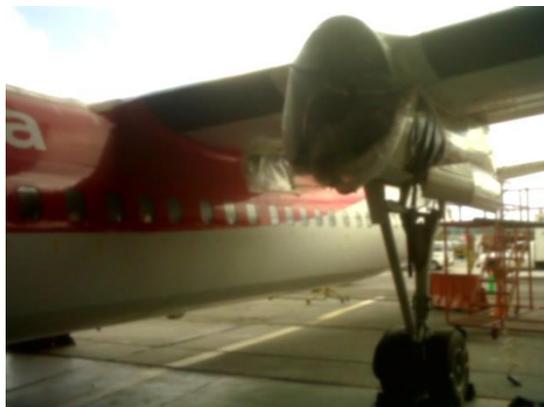
The third part is a simulated practical situation where the engineers need to determine if there are potentially harmful dents on an aircraft wing. The inspected aircraft wing is shown in Figure 6.

FIGURE 6. AIRCRAFT WING TO BE TESTED

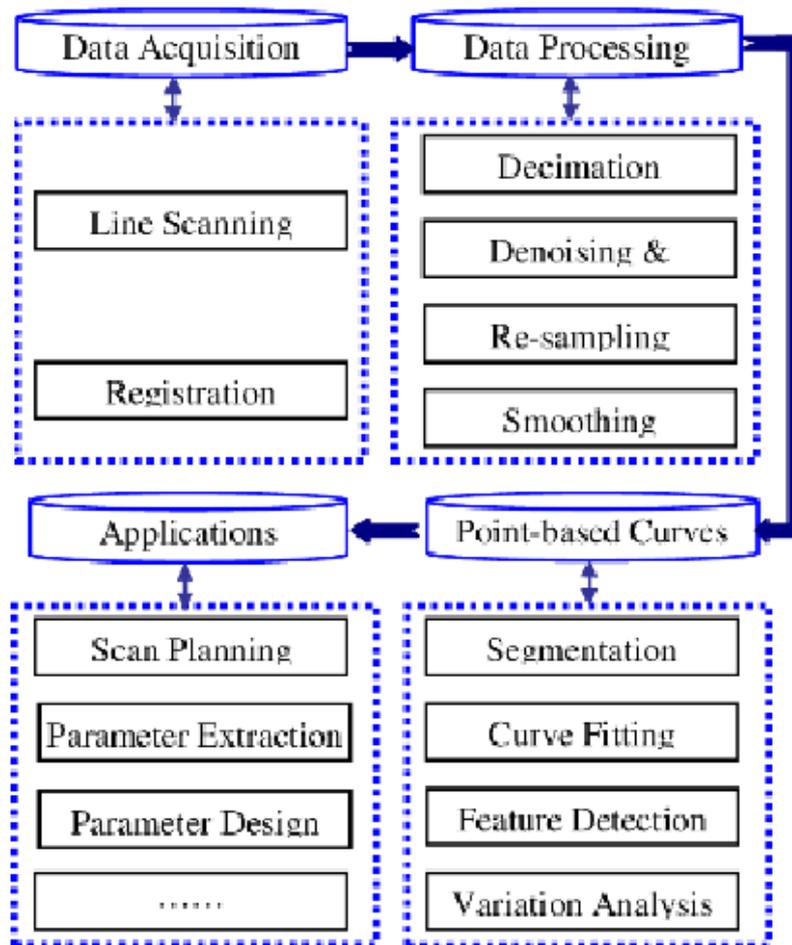
The processing of the data is divided into the development of two types of different techniques and methodologies. The first area is identification techniques and the second one is mensuration techniques. Figure 7 shows the processing framework used to create the identification and mensuration techniques.

FIGURE 7. DATA PIPELINE AND PROCESSING FRAMEWORK (CHEN, DU, JIA, & SONG, 2010)

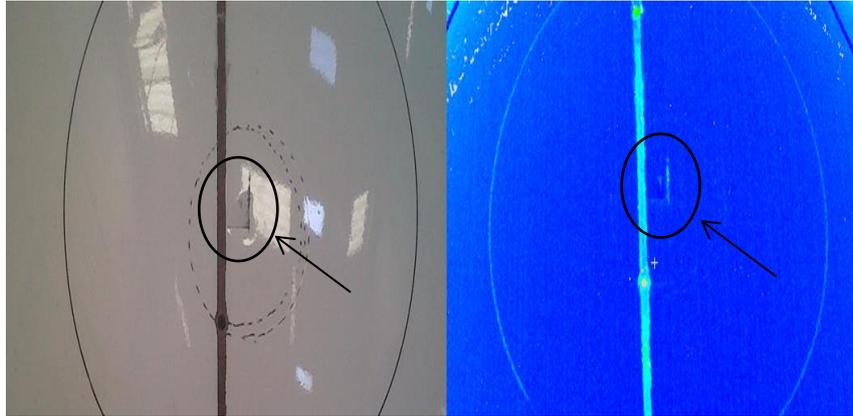
Because the near-infrared nature of the scanner, it is possible to detect different levels of intensity in the raw point cloud. The intensity map is determined by several factors, some are listed below: material type, angle of incidence, strength of the reflected signal, sharp discontinuities or edges. Figure 8 shows a photo of a nose radome of quartz fiber and the raw point cloud displaying the intensity map.

Figure 8. Intensity map of a nose radome specimen

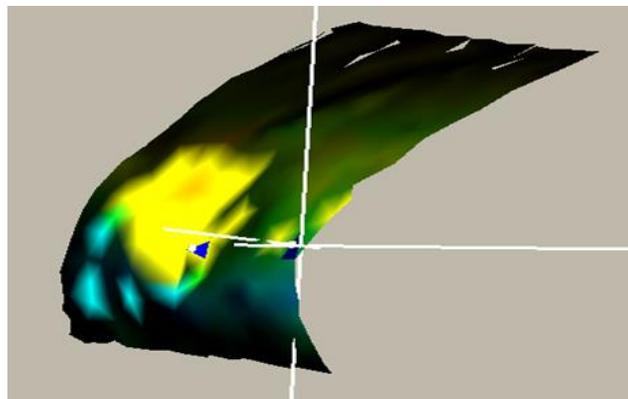
The point cloud can be processed to create a mesh in order to obtain a smooth surface of the measure. By placing an imaginary light adjacent to the surface it is simple to identify a discontinuity at the surface. This is possible because the reflectance mesh properties. Figure 9 shows the post-processed mesh of the measured leading edge.

FIGURE 9. SHADED SURFACE OF LEADING EDGE

The white vertex at the edge of the surface represents the inserted Point Light (PL). A PL source emits light in all directions of the model and the shaded surface is the one that represents a smooth surface without sharp discontinuities. Along these lines, it is possible to identify a dent or a series of them by applying this technique and identify the highlighted sections of the surface.

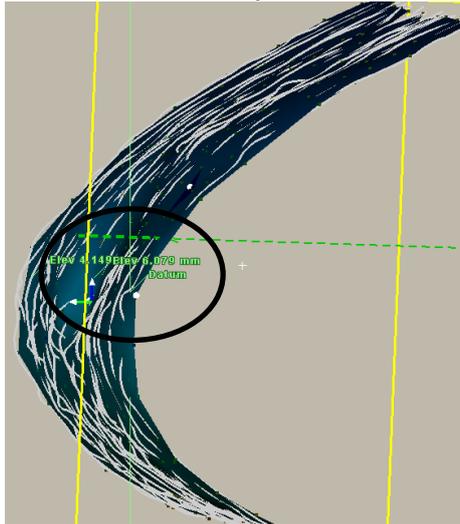
A datum can be taken at the regular surface of the leading edge. Different points on the dent can be measured to estimate de maximum depth of the dent. The depth of the dent must be

measure using one edge of the local coordinate system.

Figure 10. Datum data for the leading edge

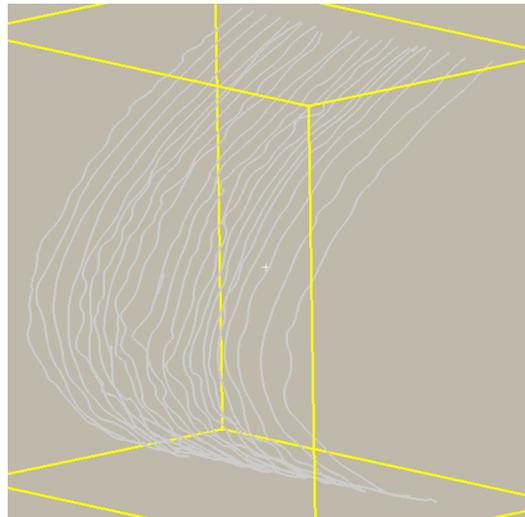
As manner of curve fitting command, the surface can be divided in a series of slices. From every slice, points along the surface are taken to know the 3D coordinates of the point. A spline is traced as representation of measure process. Figure 11 shows this representation.

FIGURE 11. REPRESENTATION OF SPLINES IN DIFFERENT SLICES

For the measure the coordinates of the point are processed to fit a cubic spline at a slice without the dent and one with the dent. The difference between the plots of the obtained equations will let us know the shape of the regular leading edge and the damaged one.

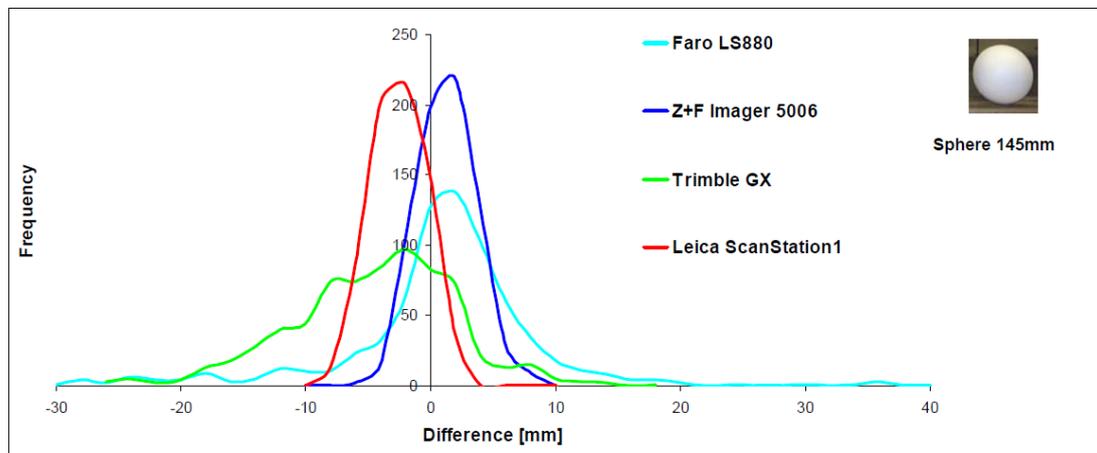
FIGURE 12. DISTRIBUTION OF DIFFERENCES BETWEEN SCANNED DISTANCES AND REFERENCE DISTANCES FOR FOUR TESTED TERRESTRIAL LASER SCANNER (KERSTEN, MECHELKE, LINDSTAEDT, & STERNBERG, 2009)

Figure 12 shows us that the maximum difference between a scanned distance and a reference distance is between 1 and 5 mm.

The measures at 2 and 4 meters were not reliable because the dispersion of the point was elevated and some parts of the surface were not measured. It appears that at these distances the scanner lost a lot of information due to noise angle of incidence. This finding is consistent with those from other results (Ross, Harding, & Eric, 2011). References were consulted and then it was known that a similar phase based Faro laser scanning was tested and results are shown at Figure 12.

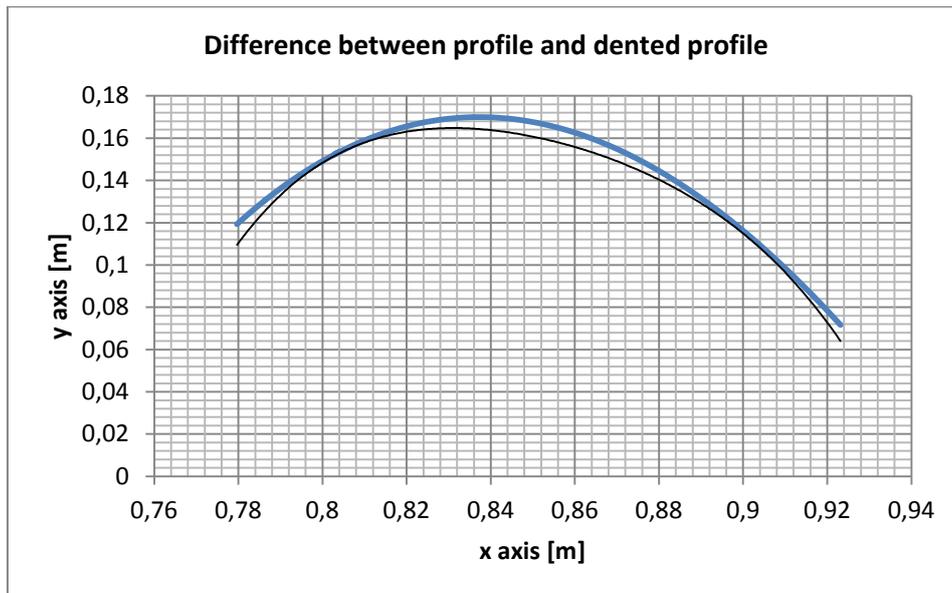
FIGURE 13. DIFFERENCE BETWEEN PROFILE AND DENTED PROFILE

Figure 13 shows the difference between the fit of a cubic spline to a regular surface section and a dented section. The basic concept behind this method is to calculate, mathematically, the approximated difference at any point between a given non-damaged profile and the approximation of the dented profile. This analysis can be fast-performed and determine if the profile needs a more detailed measure and analysis.

The maximum difference was 6 mm. This is larger than the measures with the previous method. However, it is still approximate for the previous readings of 7-10mm. This type of method approximate the measure by a mathematical formula, but it was still in doubt is if the real measure is the maximum or the minimum of the approximation.

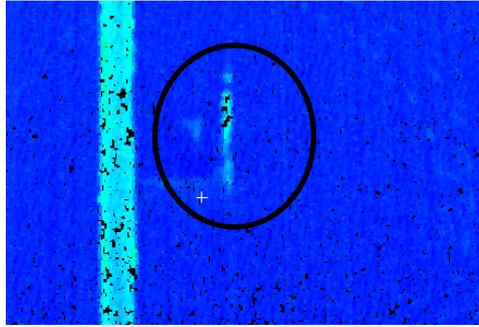
The four meters measure was inappropriate. This is because the shiny surface of the radome and reasons explained in chap 6.1. The eight meters measure is presented on figure 14. It is easy to identify by light intensity the scratch on the radome.

FIGURE 14. NOSE RADOME, SCRATCH IDENTIFICATION

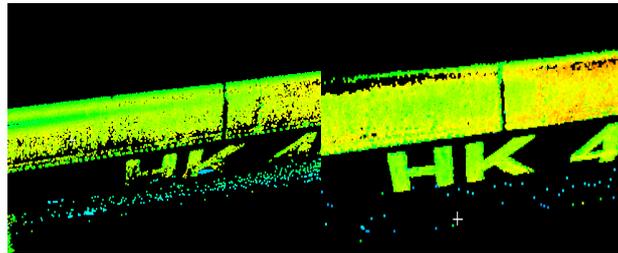
The measures at practical situation show us that the shiny surface of most of airplanes is the major challenge for the laser scanner applicability. Figure 15 shows the measured point clouds of the wing measured. The black color represents no data collected by the scanner. And the data collected represents surfaces with mate colors.

Figure 15. Wing measured, left at 8 meters/right at 4 meters
