## Photo surveys with drones. The improvement of OSOM+, the systematic monitoring of maritime works

**Key words:** UAV; drone; photogrammetry; monitoring; breakwater

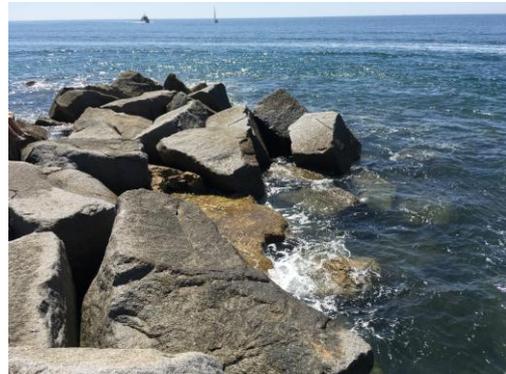
Figure 1 – Photograph taken during a visual observation campaign of a breakwater

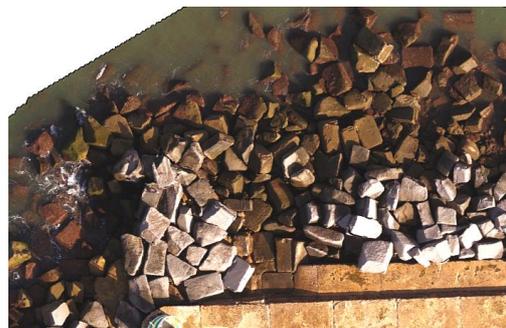
Figure 2 – Detail of the orthomosaic of the area presented in Figure 1

Since 2015, the OSOM methodology has been improved and updated so that it is now termed the OSOM+ methodology (Fortes *et al.*, 2019). Those improvements include the use of different survey methodologies (Figure 2), the enhancement of the ANOSOM database and the development of a mobile app to employ during the observation campaigns.

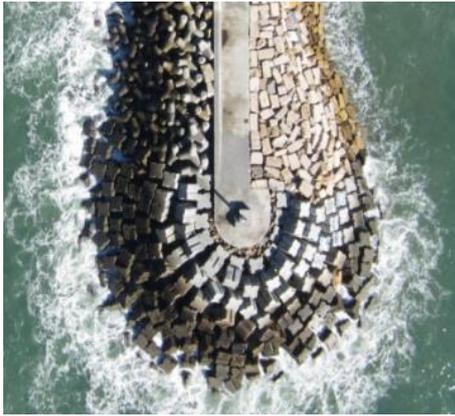
Figure 3 – Photograph taken in 2013

Photographs can, by themselves, provide much information about the structures (Figures 3 and 4). However, the products generated with these photos - orthomosaics, point clouds, numerical models of the surfaces, profiles - are more valuable to the institutions responsible for structural safety and security. They

easily allow studies of temporal evolution and can generate quantitative information, important for those who have to calculate distances and/or volumes. As an example, Figure 5 presents a comparison of two numerical models of a breakwater, generated from two photographic surveys performed in 2013 and 2018 (Figures 3 and 4). One can easily detect several changes at the breakwater's head.

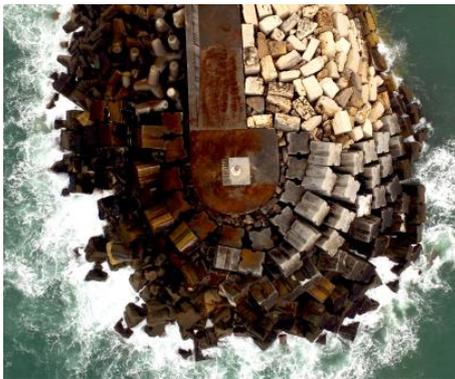
Figure 4 – Photograph taken in 2018

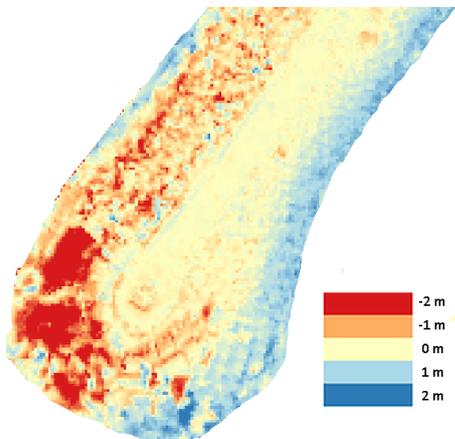
Figure 5 – Height changes of a breakwater head between 2013 and 2018

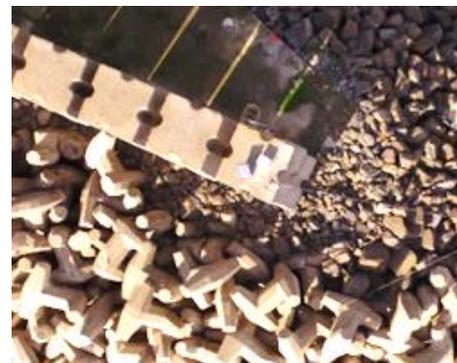
Figure 7 – Surface of a breakwater with an accessible area (painted orange points are perceivable) surrounded by an area covered with rock and Dolos blocks (these ones at the bottom of the photo)

Theoretically, GCP should be spaced strategically throughout the surveyed area. However, due to the physical characteristics of the majority of the rubble-mound breakwaters, with the armour slopes made of big inaccessible blocks of concrete or rock (see the Dolos blocks in Figure 7), the surveyors only have an easy and safe access to the structure crest and, sometimes, to a small area around it. For this reason, most of the time, GCP and CP are concentrated in a narrow strip along the crest, leaving large areas without GCP or CP.

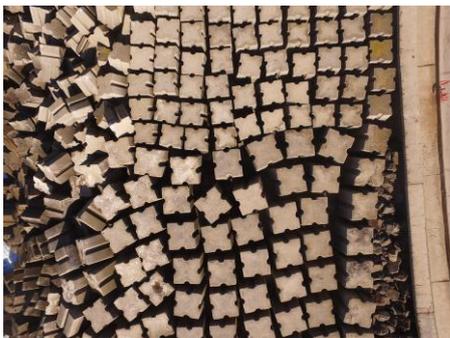
Figure 8 – Aerial photograph of a breakwater made of Antifer blocks, regularly placed

Very few rubble-mound breakwaters have the armour layer made with parallelepiped blocks placed with the top faces horizontal or sub-horizontal, like the ones presented in Figures 8 to 11. Although one could think that in this kind of armour layer it is possible to mark GCP throughout the whole surface, the reality is quite different. Not only, in some areas, the distance between blocks does not allow the passage between them, but also, quite often, the surface of the blocks is covered with a thin layer of slime, which makes them slippery.

The time spent to mark and coordinate the points is always much longer than the time needed to make the photographic survey. Take the example of the breakwater presented in Figures 8 to 11 (breakwater C in Table 1). The photographic survey, carried out with four flights, took 45 min (including the preparation of the flights and battery changes). The GCP marking and coordination took five hours. Usually, the time spent in these last operations is shorter (two to three hours in long breakwaters and less in shorter ones), because points are located only at the breakwater crest, a place easily accessed.

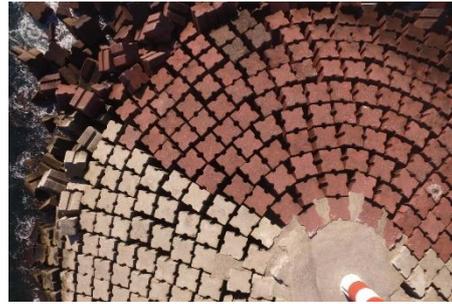
Figure 9 – The head of the breakwater presented in Figure 6

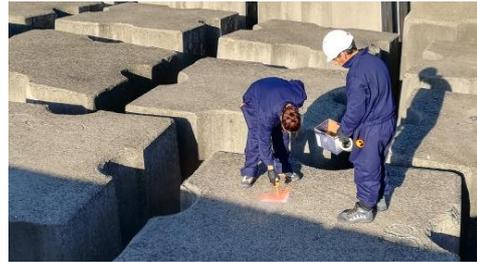
Figure 10 – Coordinating a GCP. The greenish colour of the surface of the blocks is due to slime

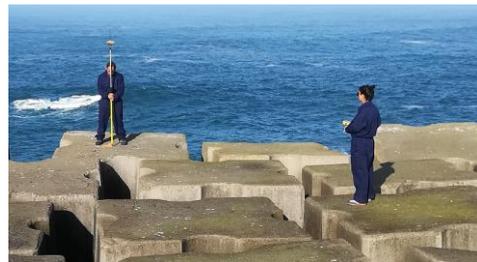
Figure 11 – Coordinating a GCP. The greenish colour of the surface of the blocks is due to slime

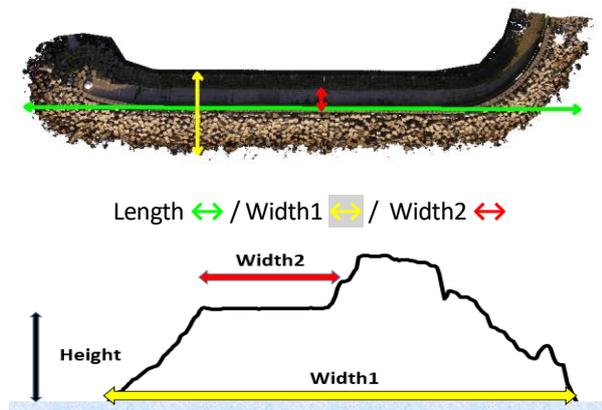
Figure 12 – Locations where the lengths presented in Table 1 were measured

To derive some conclusions, the team used photographs of aerial surveys of sections of three different breakwaters, all carried out during low tides. Table 1 presents information concerning these breakwater sections: the length, height and widths .. The locations where these lengths were measured are shown in Figure 12

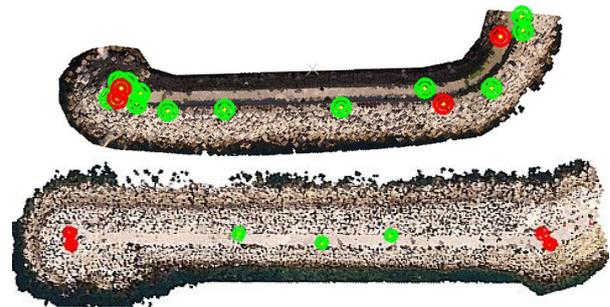
Figure 13 – Location of the GCP in breakwaters A and B

When four GCP were used, these were located near the limits of each section (see the red circles in Figure 13). A larger number of GCP means that more points (green circles in Figure 13) were added to the set.

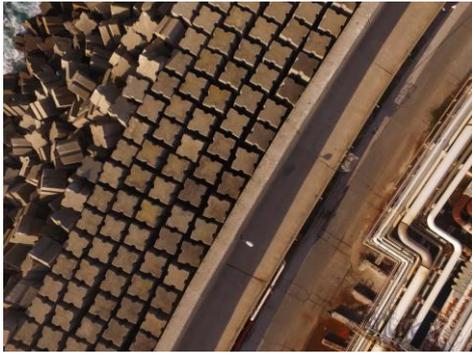
Figure 15 – Aerial photograph of breakwater C. Antifer blocks on the left side, the superstructure in the center, two roads and pipes on the right side

Breakwater C (Figures 9 to 12 and 15) has different characteristics. It has not a concrete superstructure at the crest. On the inner side, there are two parallel roads at different heights (5 m and 10 m). Between the roads and the concrete blocks (top at 15 m), there is a concrete wall (top at 16.5 m). These elevations are average values.

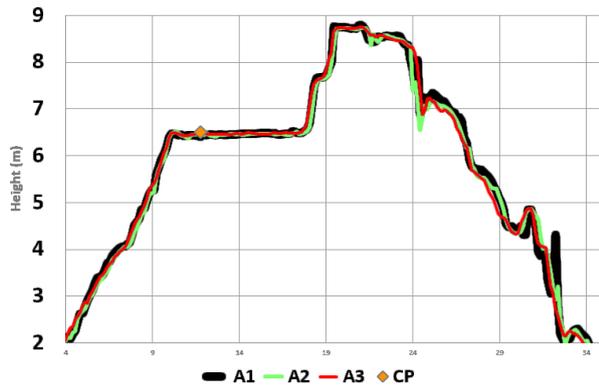
Figure 16 – Cross-sectional profiles of breakwater A

Cross-sectional profiles of the three breakwaters are presented in Figures 16 to 18. These profiles were extracted at the center of the breakwaters. The profiles of breakwaters A and C include, each, a CP.

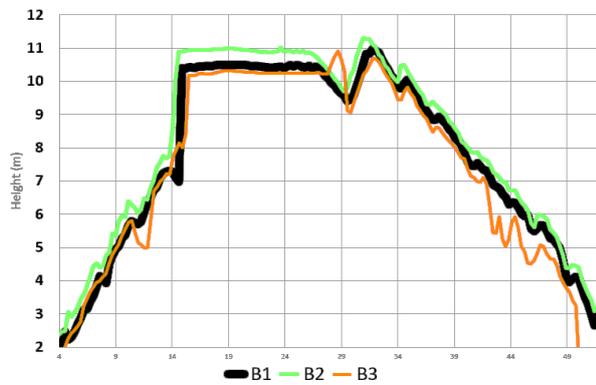
Figure 17 – Cross-sectional profiles of breakwater B

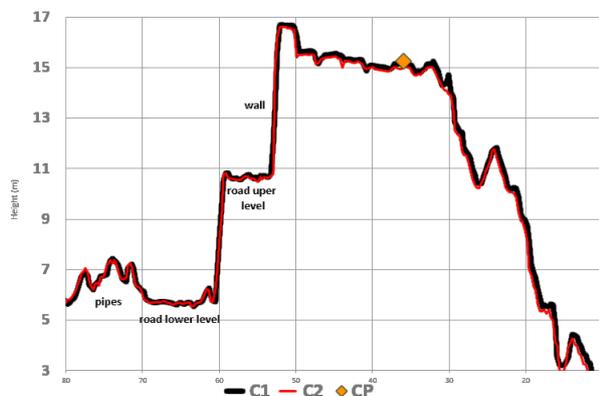
Figure 18 – Cross-sectional profiles of breakwater C

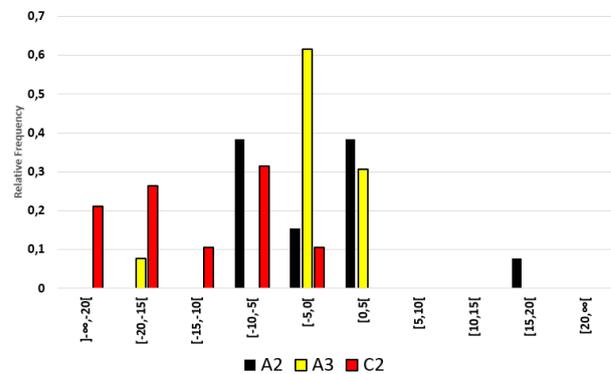
Figure 19 – Distribution of vertical distances between clouds and CP

In some versions of the tests performed, it were generated points clouds with a small number of GCP (clouds A2, A3 and C2, see Table 2). These clouds have a large number of CP. In each of these three clouds the vertical distance between each CP and the nearest point of the cloud was determined by the tool “Closest point set” of the software Cloudcompare. These vertical distances were grouped according to the ten intervals presented in Figure 19 (X axis). Then the relative frequency was determined and presented as chart in Figure 19. Comparing the results of point clouds A2 and A3 one can notice that cloud A3 is the closest to the CP (75% of the points analyzed are at a distance from a CP shorter than 5 cm). On the other hand, the points analyzed in point cloud C2 are the furthest from their respective CP, being almost all lower than the CP (negative differences).
